FINAL REPORT

Low Temperature Cure Powder Coatings

ESTCP Project WP-200614

October 2010

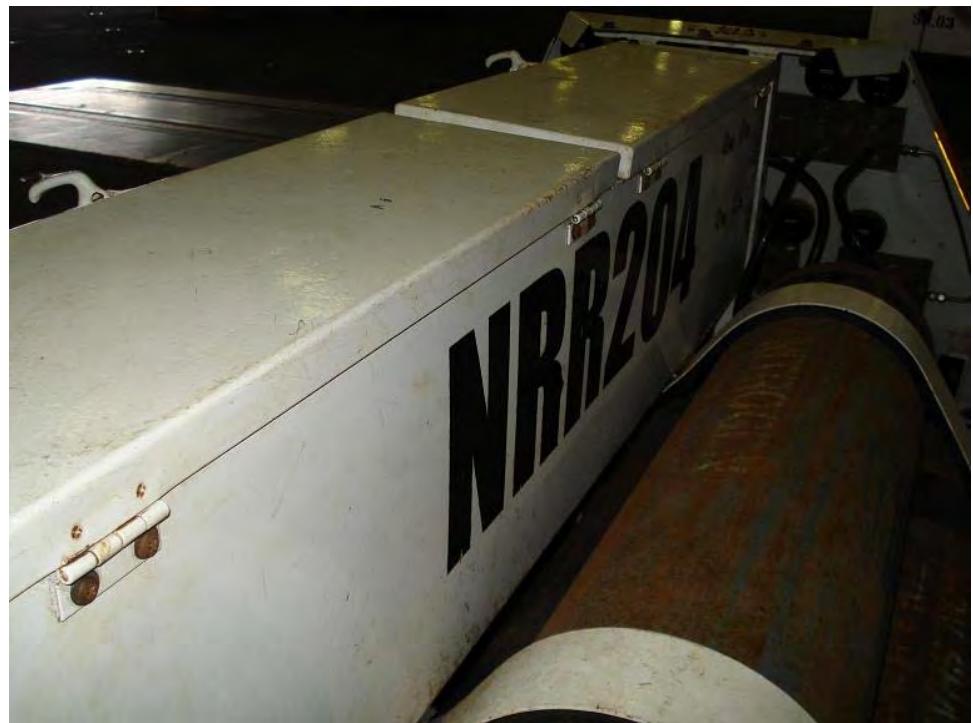
Figure 45. Nitrogen Servicing Cart (SN: NRR204) After 6 Months of Carrier Exposure

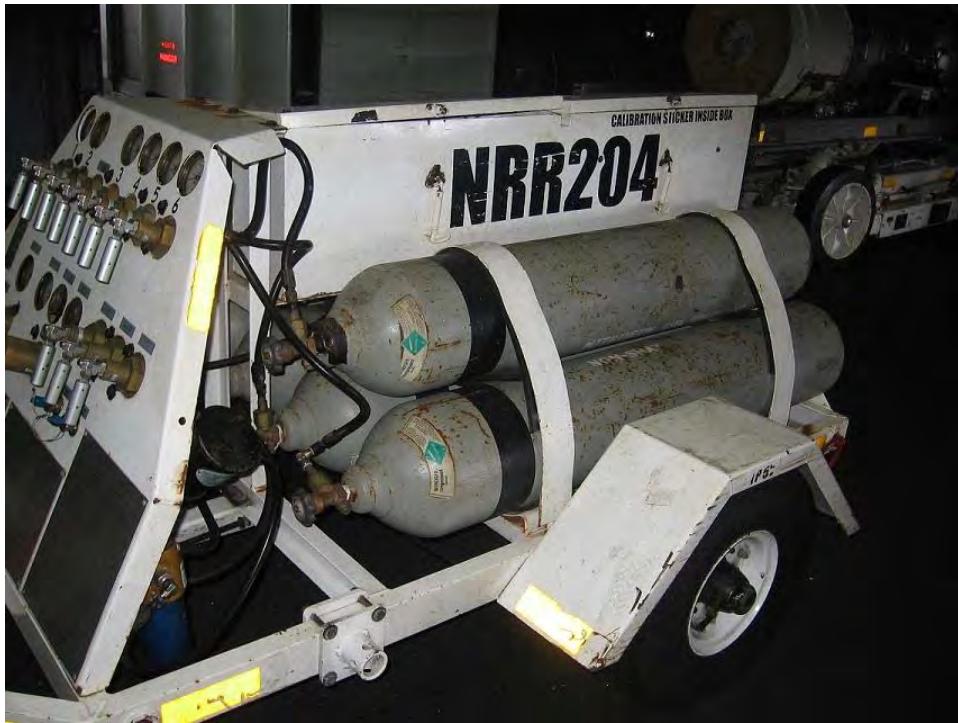
Figure 46. Nitrogen Servicing Cart (SN: NRR204) After 18 Months of Carrier Exposure

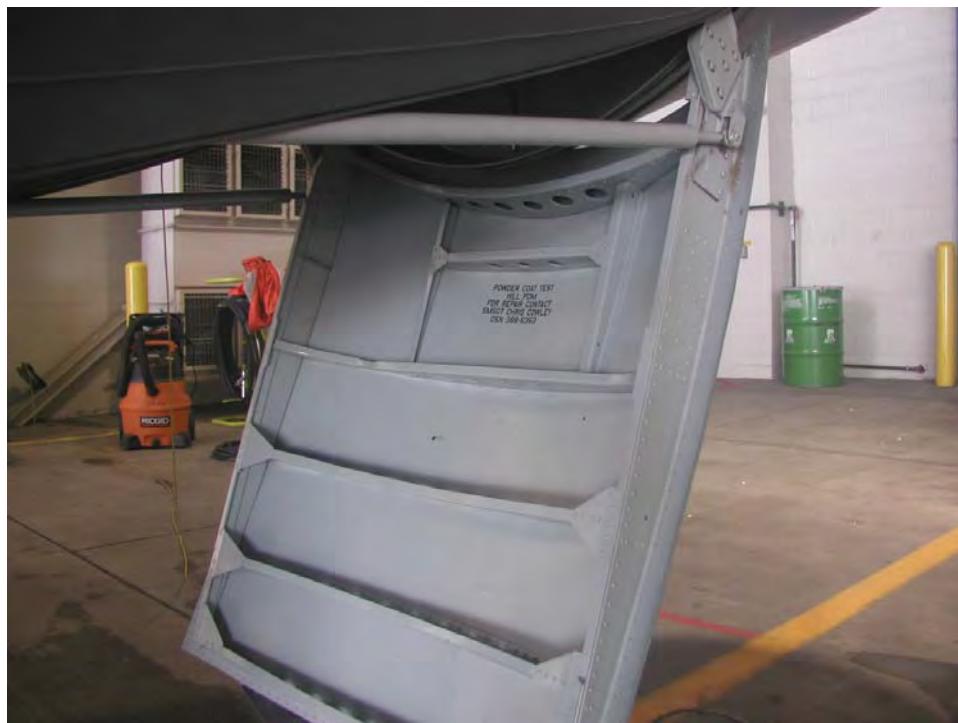
Figure 50. C-130 Nose Landing Gear Forward Door (AC: 92-1534) After 12 Months of Exposure

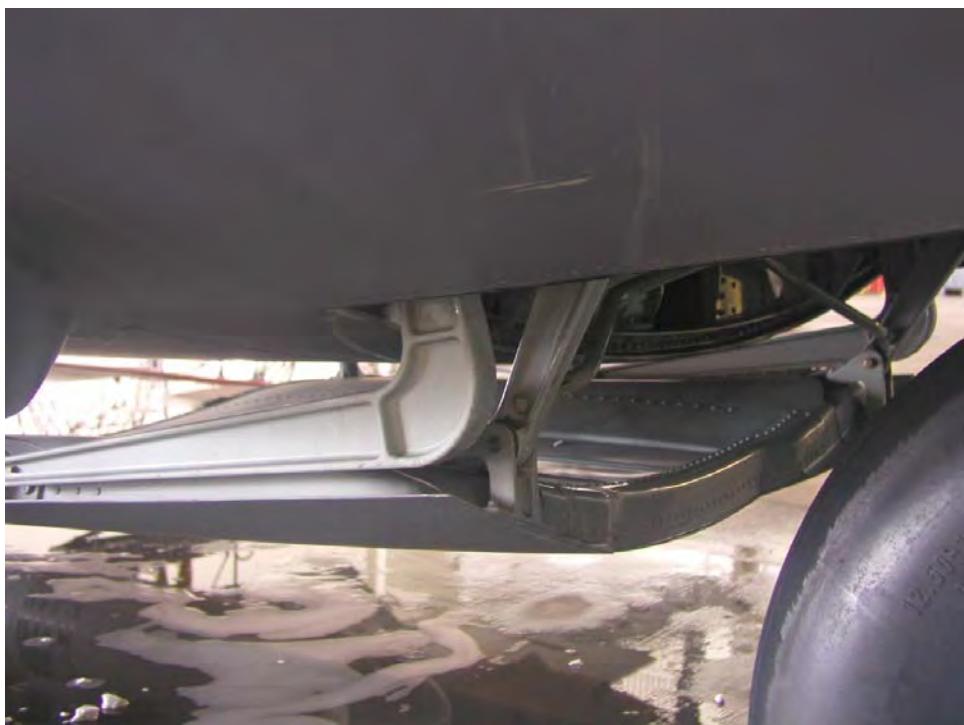
Figure 51. C-130 Nose Landing Gear Aft Door (AC: 92-1534) After 12 Months of Exposure

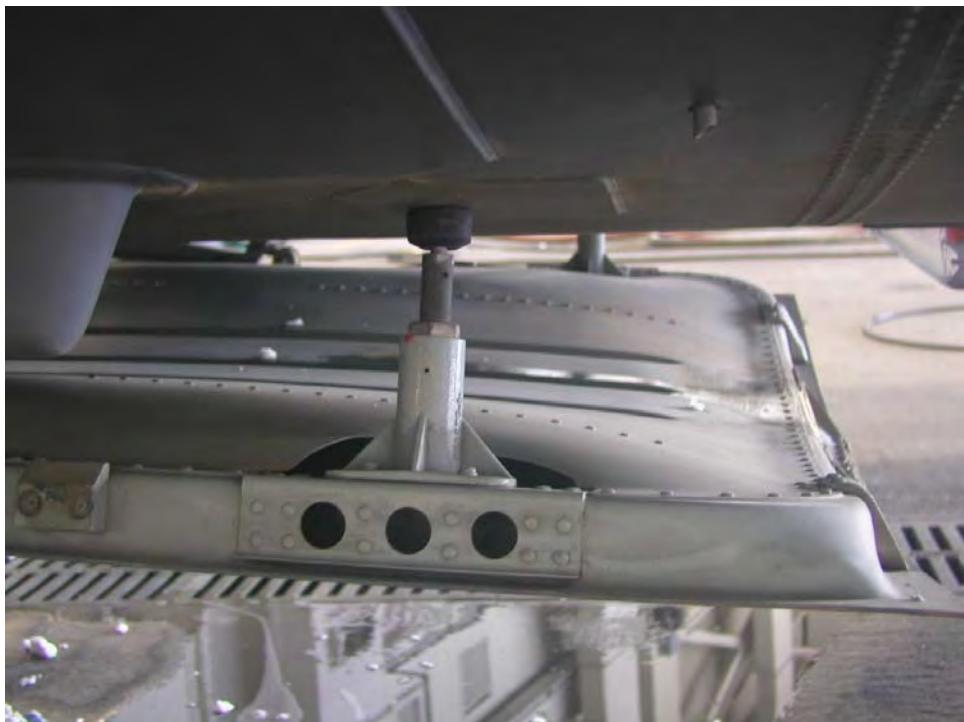
Figure 52. C-130 Nose Landing Gear Aft Door (AC: 92-1534) After 12 Months of Exposure

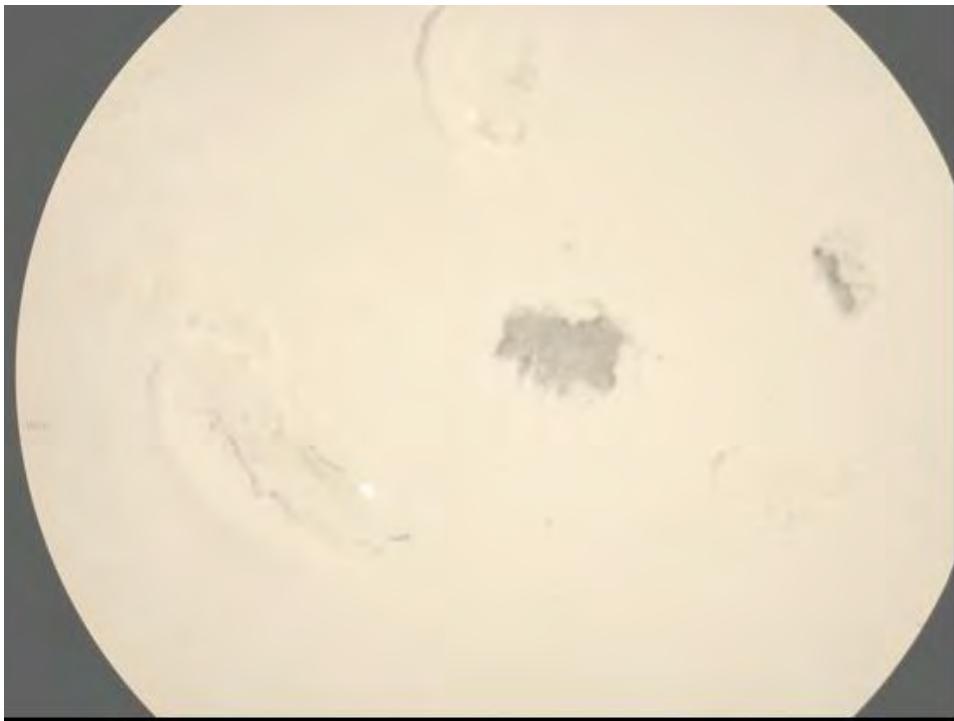
Figure 56. LTCPC Chipping Resistance Test Outcome

Chipping resistance tests confirm that LTCPC performance equals or exceeds the results observed for the selected baseline stack-up. The 2024-T3 LTCPC specimens exhibited lower

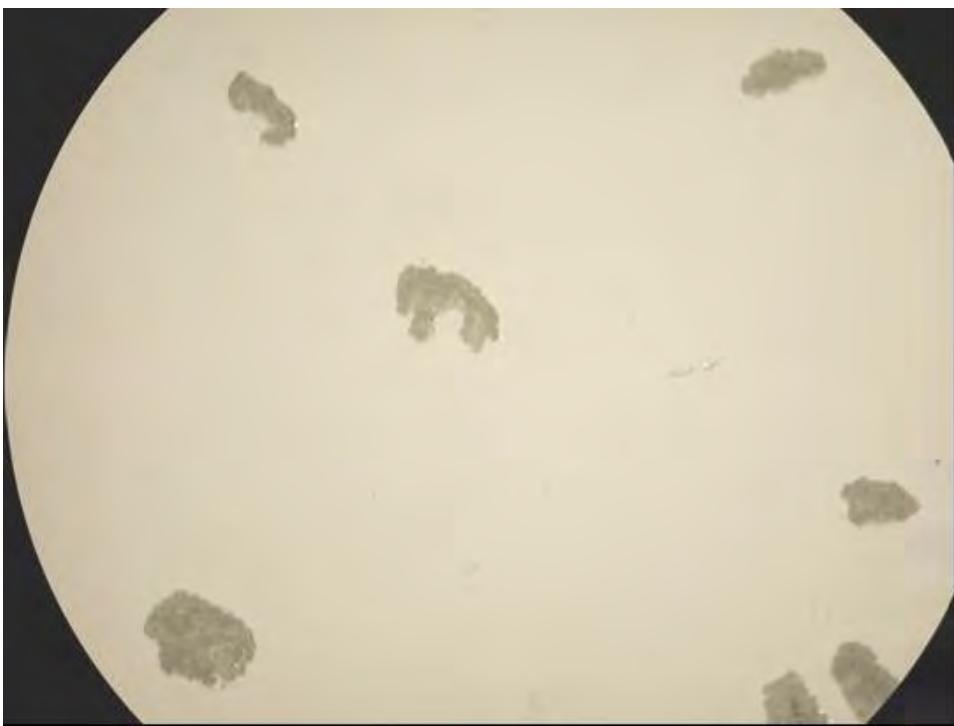
Figure 57. Control Coating Chipping Resistance Test Outcome

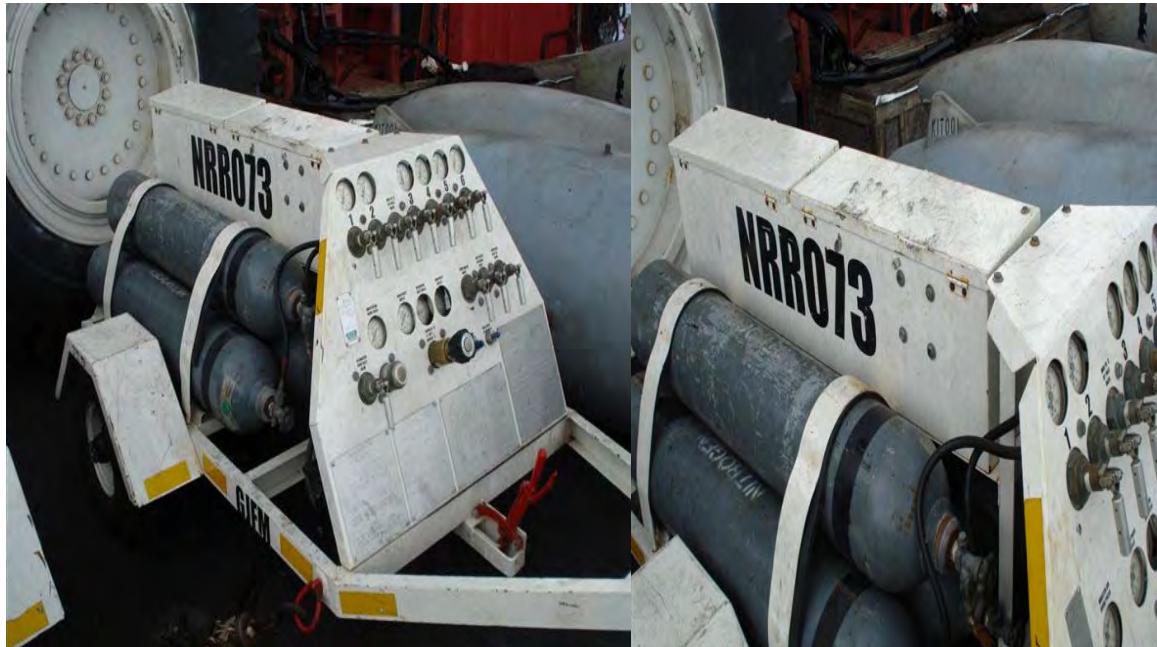
Comments and observations: UNIT HAS A LITTLE CORROSION ON THE BOXES, AROUND THE HINGES MINOR CORROSION. PAINT IS HOLDING UP WELL.

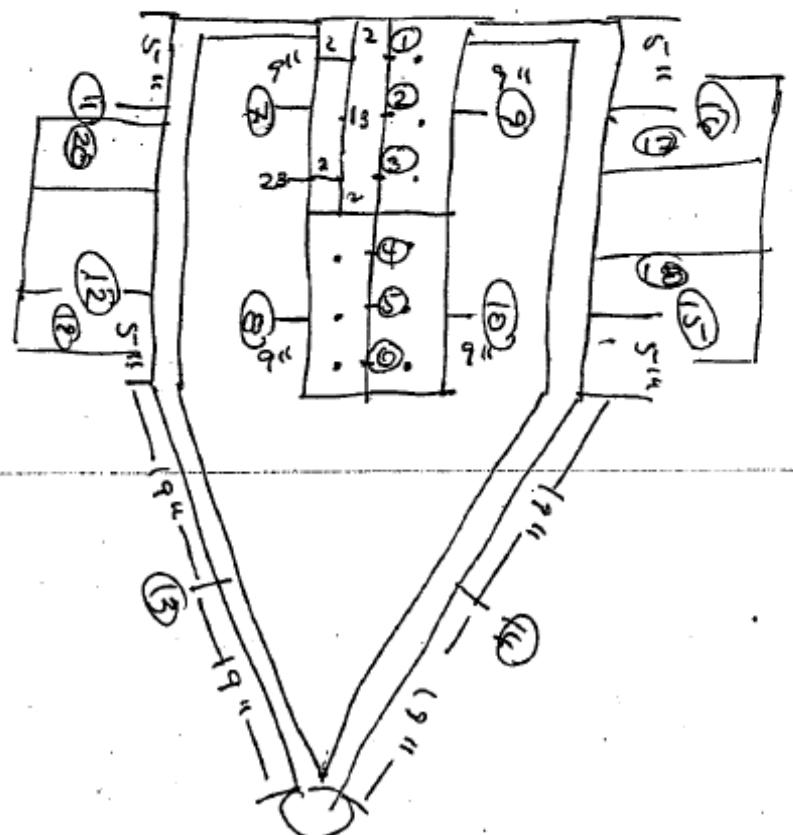
Reading	Data	Comments
1	60° 46.1 l* 85° 79.4 a* DFT 6.39 b* Trial	
2	60° 52.5 l* 85° 79.0 a* DFT 5.59 b* Trial	
3	60° 46.4 l* 85° 78.3 a* DFT 6.18 b* Trial	
4	60° 28.7 l* 85° 72.7 a* DFT 5.54 b* Trial	
5	60° 38.9 l* 85° 70.2 a* DFT 5.81 b* Trial	
6	60° 34.0 l* 85° 71.3 a* DFT 6.40 b* Trial	Stain in measurement area.

7	60° <u>59.7</u> L* 85° <u>88.2</u> a* DFT <u>5.52</u> b* Trial	
8	60° <u>55.0</u> L* 85° <u>74.3</u> a* DFT <u>5.56</u> b* Trial	
9	60° <u>44.1</u> L* 85° <u>86.2</u> a* DFT <u>9.20</u> b* Trial	
10	60° <u>69.3</u> L* 85° <u>89.3</u> a* DFT <u>7.45</u> b* Trial	
11	60° <u>10.2</u> L* <u>85° 36.1</u> a* <u>DFT 12.0</u> b* Trial	60° : 57.6 Rewrite prior to. 85° : 81.5 new readings. DFT : 11.9
12	60° <u>49.0</u> L* 85° <u>79.3</u> a* DFT <u>8.61</u> b* Trial	
13	60° <u>28.6</u> L* <u>85° 54.5</u> a* <u>DFT 5.94</u> b* Trial	60° : 50.9 Rewrite prior to. 85° : 56.9 new readings DFT : 4.97 Cleared off at scratch.

14	60° 63.6 L* 85° 82.4 a* DFT 7.56 b* Trial	
15	60° 69.4 L* 85° 87.8 a* DFT 10.1 b* Trial	
16	60° L* 85° a* DFT b* Trial	Rusted/work area due to tie-down chain prevents taking reading.
17	60° 42.0 L* 85° 75.1 a* DFT 5.85 b* Trial	
18	60° 67.6 L* 85° 89.9 a* DFT 7.55 b* Trial	
19	60° 56.5 L* 85° 86.9 a* DFT 7.14 b* Trial	
20	60° 39.8 L* 85° 81.3 a* DFT 8.19 b* Trial

Additional Notes: Much less surface than -073; however, bottles much more corroded. Bottles are not dedicated to the cart! They may be changed out and replaced.

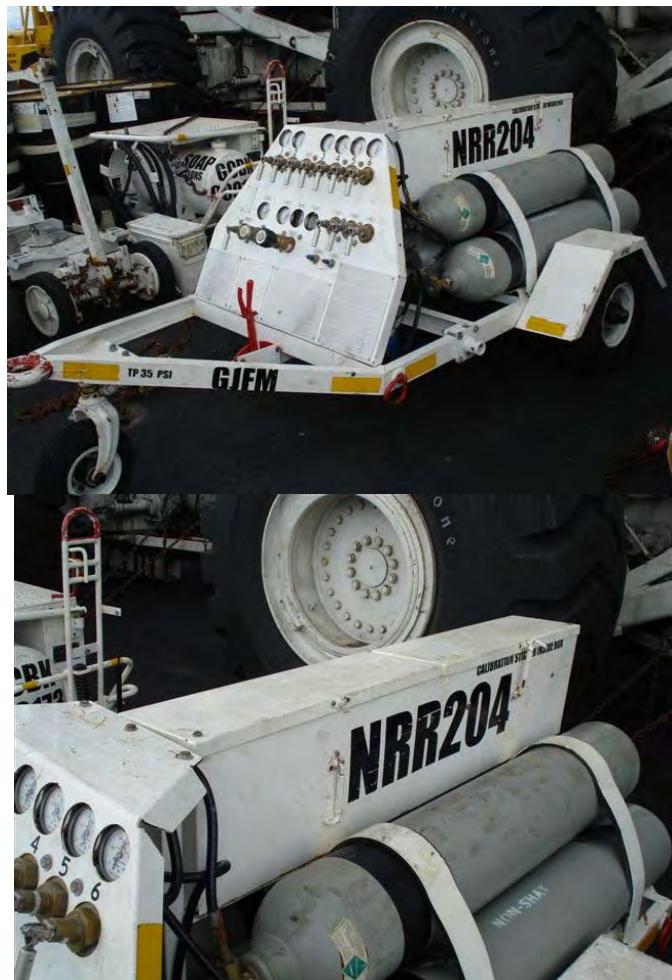
Comments and observations: CONDITION OF UNIT IS WITH STANDING FLIGHT DECK USE ON A DAILY BASIS. MINOR SCRATCHES ON FENDERS AND MAIN FRAME BUT OVER-ALL POWDER COATING IS STILL GOOD. NITROGEN BOTTLES HAVE BEEN REPAINTED DUE TO SURFACE CORROSION.

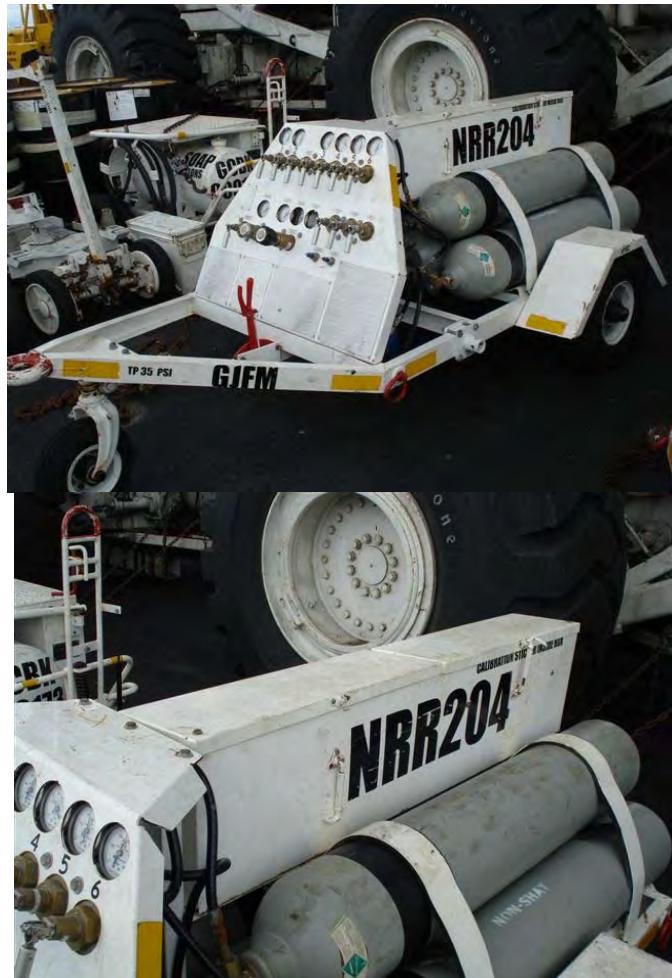
Comments and observations: CONDITION OF UNIT IS STILL THE SAME AS REPORTED IN NOVEMBER 2008. MINOR SCRATCHES ON FENDERS AND MAIN FRAME BUT OVER-ALL POWDER COATING IS STILL GOOD. NITROGEN BOTTLES HAVE BEEN REPAINTED DUE TO SURFACE CORROSION.

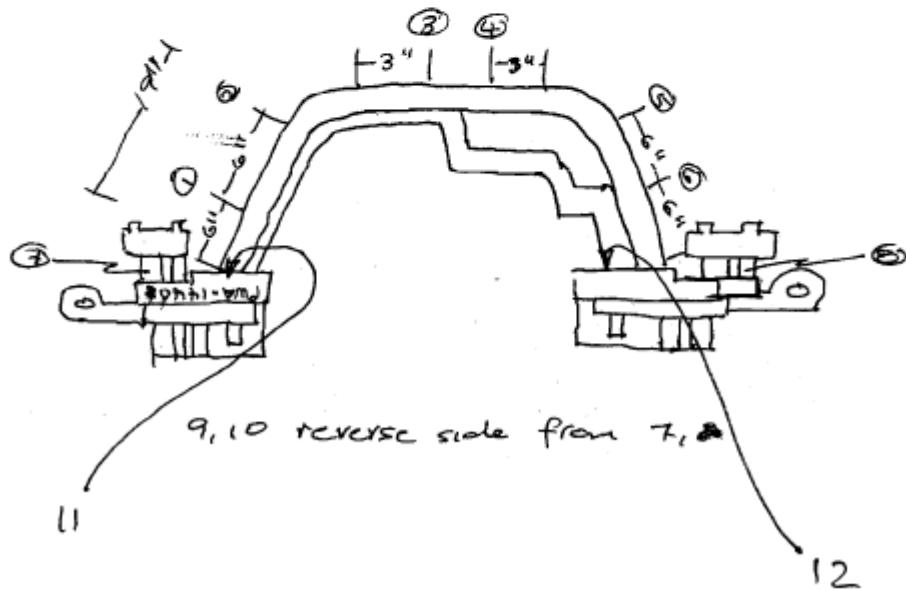
7	60° 85° DFT 2.5 Trial NT	L* NT a* NT b* NT <i>Part in way preventing measurement</i>
8	60° 85° DFT 2.5 Trial NT	"
9	60° 85° DFT 5.5 Trial NT	"
10	60° 85° DFT 2.5 Trial NT	"

*Some drag wear but minimal abrasion.
Wear on bottom of tube.*

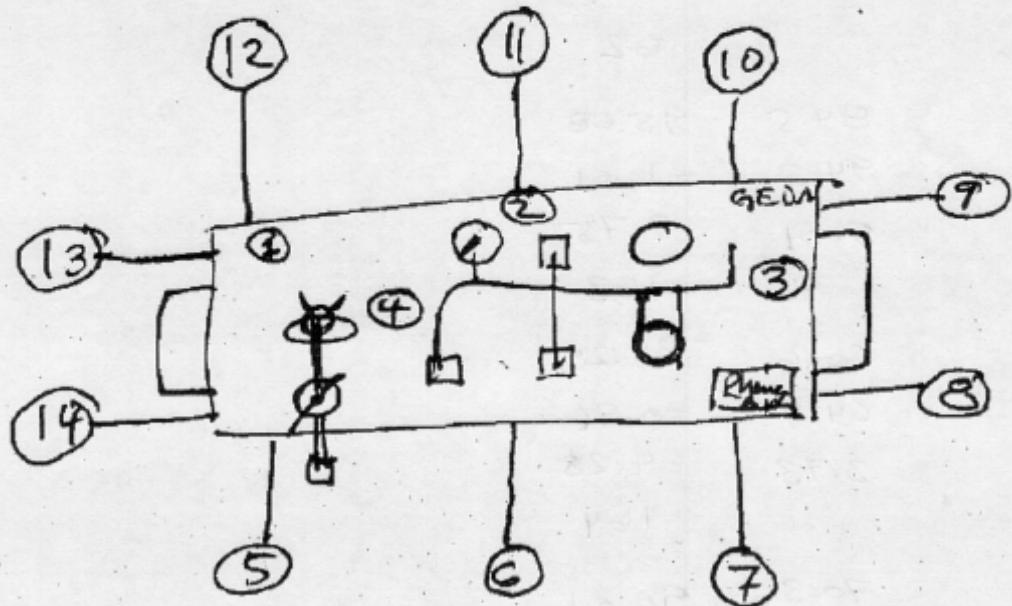
7	60° 70.7 L* 96.27 85° 93.2 a* -1.07 DFT 4.23 b* 4.25 Trial 167	
8	60° 67.4 L* 94.72 85° 55.6 a* -1.21 DFT 2.74 b* 3.57 Trial 168	
9	60° 78.4 L* 95.26 85° 95.5 a* -1.17 DFT 3.46 b* 3.92 Trial 169	
10	60° 72.8 L* 96.76 85° 74.9 a* -0.88 DFT 4.51 b* 4.99 Trial 170	
11	60° 65.6 L* 95.81 85° 68.6 a* -1.14 DFT 3.48 b* 3.88 Trial 171	
12	60° 53.5 L* 94.07 85° 42.5 a* -1.03 DFT 3.68 b* 4.38 Trial 172	No real reason for these low readings.
13	60° 56.1 L* 95.73 85° 64.8 a* -1.00 DFT 4.58 b* 4.65 Trial 173

*Chipped
Paint scraped off due to abrasion above #1
due to regulator. Mechanical damage only.*

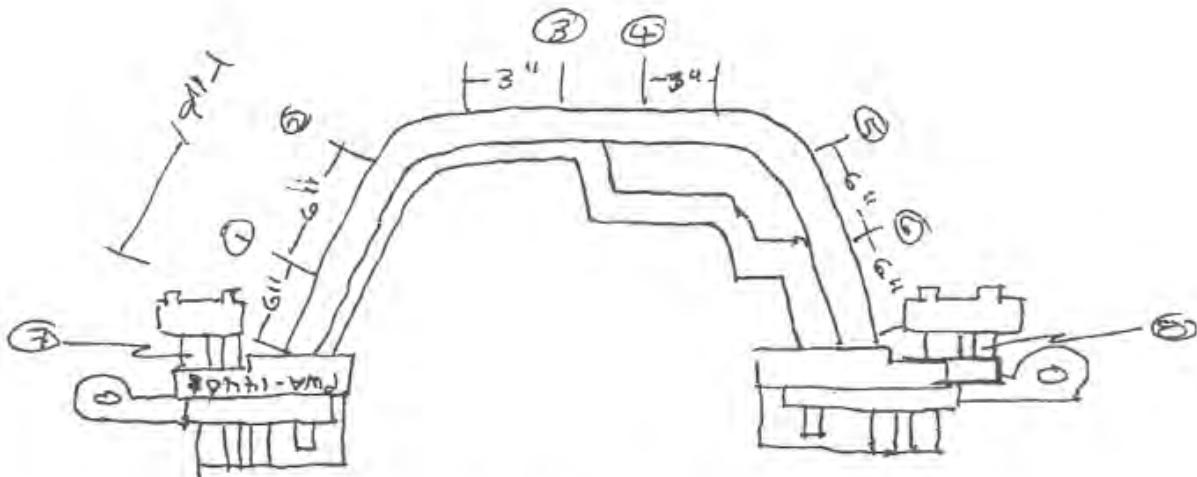
Additional Notes: Minor scratches
no significant corrosion, except around bolts
very minor scraping.

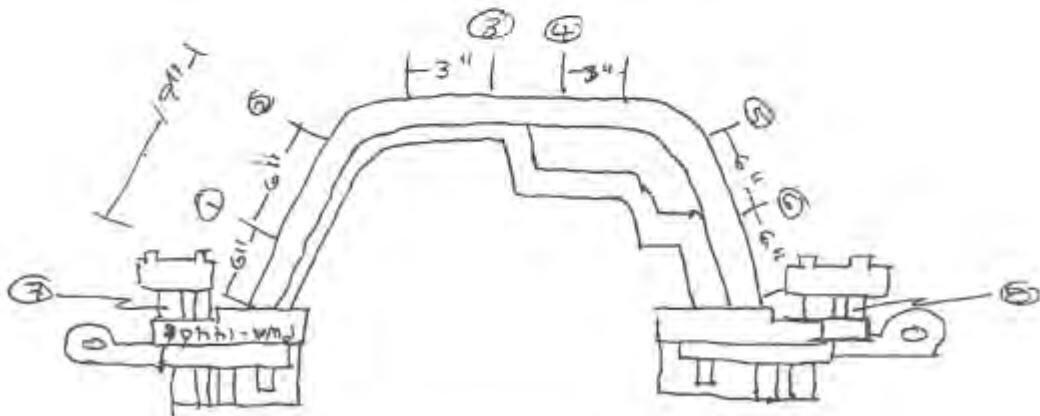
Reading	Data		Comments
1	60° NT	L* .94.4	
	85° NT	a* - .60	
	DFT NT	b* 4.17	
	Trail	38	
2	60° NT	L* 93.69	
	85° NT	a* - 0.60	
	DFT NT	b* 4.40	
	Trail	39	
3	60° NT	L* 92.65	
	85° NT	a* - 0.75	data points measured on other side, Component upside down and paint wore off -
	DFT NT	b* 3.11	
	Trail	40	
4	60° NT	L* 89.08	
	85° NT	a* - 0.64	
	DFT NT	b* 3.94	
	Trail	41	
5	60° NT	L* 92.48	
	85° NT	a* ~ 0.62	
	DFT NT	b* 4.20	
	Trail	42	
6	60° NT	L* 92.05	
	85° NT	a* - 0.83	
	DFT NT	b* 3.17	
	Trail	43

Additional Notes: Most used condition of the three

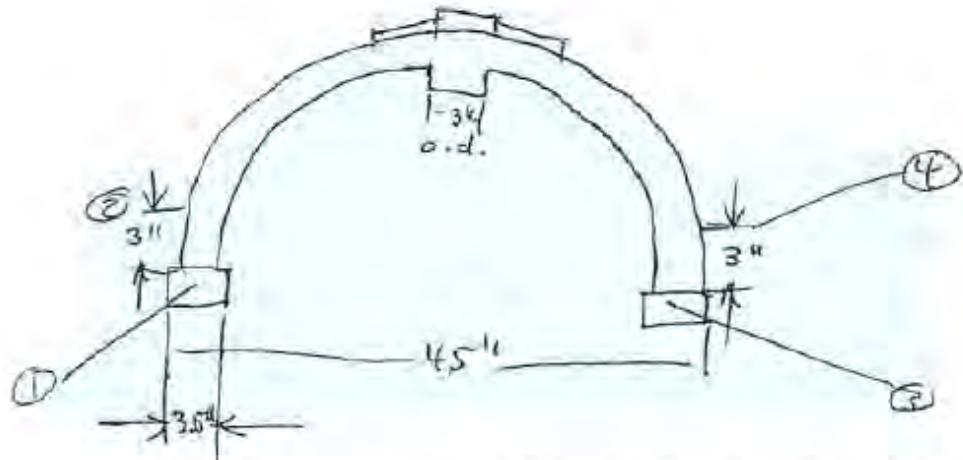
*Support adapter
cooling* to DEMO because spinning part failed.
*cutter threads stripped
performance not part of failure*
